ARBORICULTURAL REPORT

to BS 5837:2012 at:

***Premier Inn London Ruislip,
Ickenham Road,
Ruislip
HA4 7DR***

Reference: *AWA6395*

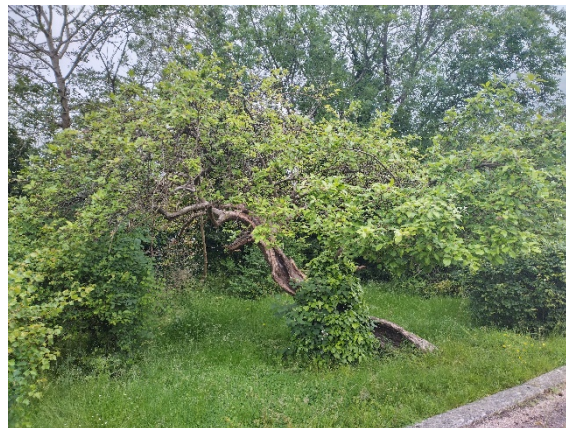
- 3.2.6 Ash T3 has symptoms of the fungal disease Ash Dieback and is recommended for removal regardless of development at the site.
- 3.2.7 Apple T8 is an early mature tree of moderate value situated at the site's south western corner. The tree leans significantly to the south west, and has likely historically failed and the stem has significant decay and is hollow.

Photo 8: T8 from east

4.2.4 Apple T8 is of moderate value and its removal will have some negative impact, however the tree has defects which may limit its long term prospects.

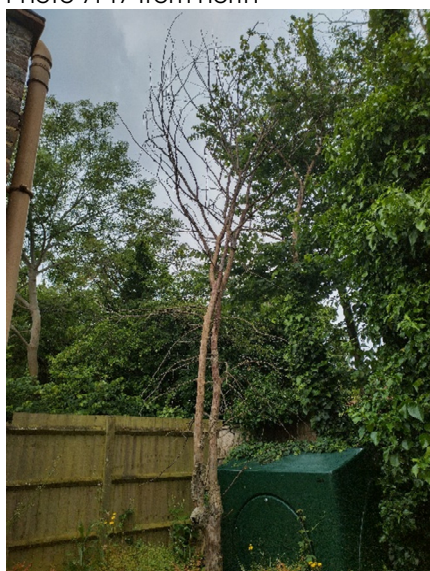
- 3.2.8 Elm T9 is dead, likely due to Dutch Elm Disease and is recommended for removal regardless of development at the site.
- 3.2.9 G16 to T35 border the site boundaries.

Photo 9: T9 from north

T9	Elm	<i>Ulmus sp.</i>	Dead	8	2	100, 90	No	1.5	1.5	1.5	1.5	2	No visual defects	Twin stemmed at 1m. Vertical. Bark damage. Bark loss. Dutch Elm Disease symptoms	Major dieback. Minor deadwood. Moderate deadwood. Dutch Elm Disease symptoms	Dead. Likely due to Dutch Elm Disease. Telephone line to south east.	Dead	Dead	n/a	Dead	U	Removal recommended regardless of development
T10	Cherry	<i>Prunus sp.</i>	Young	5	1	140	No	1.5	3	3	3.5	3.5	No visual defects	Single stemmed. Vertical	Minor dieback. Minor deadwood		Fair	Good	10 to 20 yrs	Low	C	Removal required to facilitate development
T11	Cherry	<i>Prunus sp.</i>	Young	4.5	1	100	No	1.5	2.5	2.5	2	2.5	No visual defects	Single stemmed. Vertical. Ivy covered. Stake and tie attached	Minor dieback. Minor deadwood	Ivy prevented detailed inspection	Fair	Good	10 to 20 yrs	Low	C	Removal required to facilitate development

4.2.8 T3, T9, T21, T22, G28, T33 and G34 are recommended for removal regardless of development at the site.

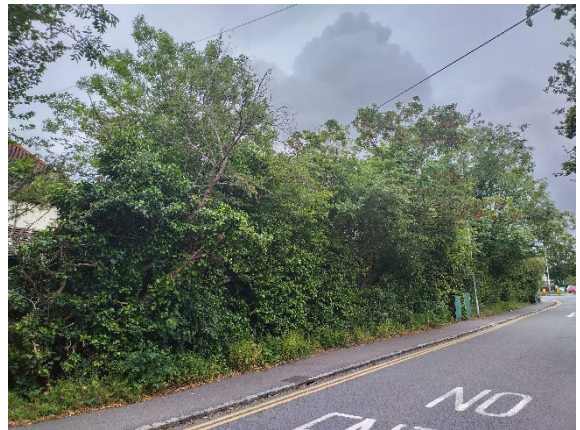
- 3.2.12 G18 forms a linear group of young to semi mature trees bordering the site's western boundary. The group is predominantly comprised of Ash and Elm with dense shrubby Hawthorn and very occasional young Field Maple and Oak. The Ash within the group have Ash Dieback symptoms and the Elms within the groups are dead or dying, likely due to Dutch Elm Disease. It is recommended to remove the Ash and Elm within the group regardless of development at the site, retaining the Hawthorn, Oaks and Field Maples. While the Ash and Elm within G18 provide established screening between the site and the adjacent residential properties, they have very limited future prospects regardless and the screening they provide could be replaced in the longer term with new tree plantings of more suitable species along the boundary.

Photo 16: G18 from north west

4.2.7 G18, G23 and T25 require pruning works to facilitate the development, reducing the crowns of G18 and G23 from the north east and T25 from the south as required to provide adequate clearance from the proposed new store.

4.2.9 The partial removal of G18 is recommended regardless of development at the site.

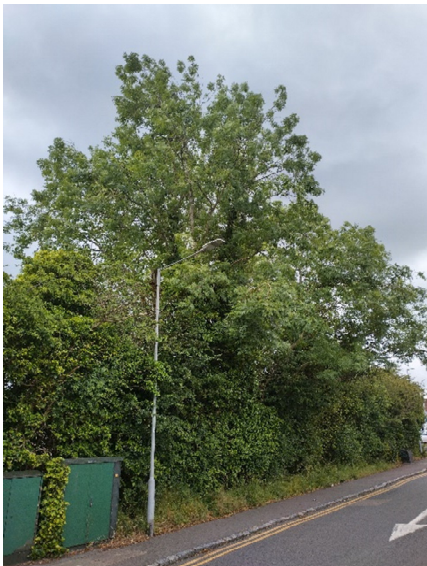
- 3.2.13 Ash T19 and Sycamore T20 are early mature individual trees also situated along the site's western boundary which are larger and more prominent than the trees within G18.

Photo 17: T19 from north west

T19	Ash	<i>Fraxinus excelsior</i>	Early-mature	19	5	350, 200, 250, 250, 200	Yes	6	6	6	6	6	Limited access around base	Multiple stemmed at base. Vertical. Tight unions. Partially included bark. Ivy covered	Minor dieback. Minor deadwood. Ivy covered	Larger tree within boundary group. Limited access due to dense undergrowth. Very Ivy covered. Ivy prevented detailed inspection. Minor dieback in crown. Bark damage in lower south western crown, likely from vehicles. Fence to immediate east. Unclear if within site boundaries or adjacent and not under site ownership.	Fair	Fair	10 to 20 yrs	Moderate	C	Removal required to facilitate development	
T20	Sycamore	<i>Acer pseudoplatanus</i>	Semi-mature	13	2	350, 350	No	5	5.5	6.5	4	5	No visual defects	Twin stemmed at 1m. Slight lean west. Ivy covered	Minor dieback. Minor deadwood. Ivy covered	Larger boundary tree. Very Ivy covered. Ivy prevented detailed inspection. Fence to immediate east. Unclear if within site boundaries or adjacent and not under site ownership.	Fair	Fair	20 to 40 yrs	Moderate	C	Removal required to facilitate development

4.2.6 T19 and T20 are larger more prominent early mature trees and their removal will have some negative impact, however Ash T19 likely has limited long term value regardless of development at the site due to Ash Dieback. The screening the trees provide between the site and the adjacent residential properties could be replaced could be replaced in the longer term with new tree plantings of more suitable species along the boundary.

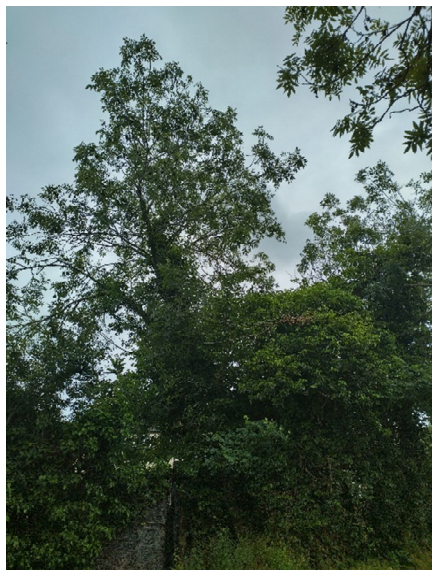
- 3.2.14 Ash T21 has a significant decayed cavity at the base of the stem and is recommended for removal regardless of development at the site.
- 3.2.15 Elm T22 is dead, likely due to Dutch Elm Disease and is recommended for removal regardless of development at the site.

Photo 19: T21 from south west

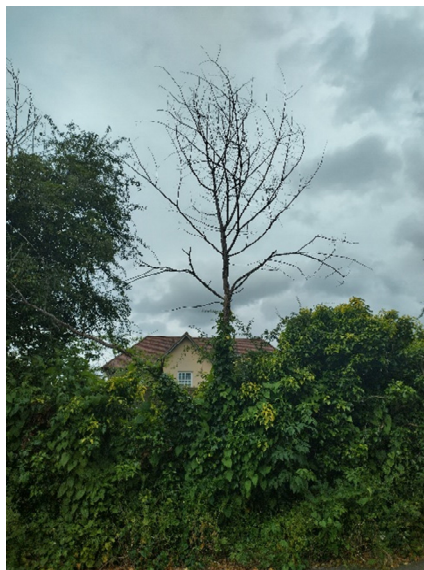
Photo 20: T22 from south west

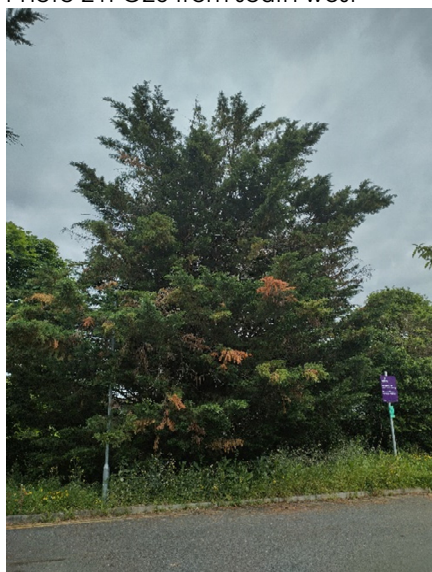
- 3.2.16 Cypress T25 is a large early mature tree at the site's north western corner. The tree could be considered unsuitably large and overbearing for its location, but it does provide effective screening between the site and the adjacent residential property.

Photo 23: T25 from south east

- 4.3.2 A plant area and footpath are proposed within the detailed RPA of retained tree T25. There is existing hardstanding within the RPA of T25 at the location of the proposed new plant area and footpath with likely significant sub-base beneath, so provided the existing hardstanding sub-base can be left in place and any new hardstanding surface splayed on top, with no excavations lower than the existing hardstanding sub-base, T25 should remain largely unimpacted by the works.

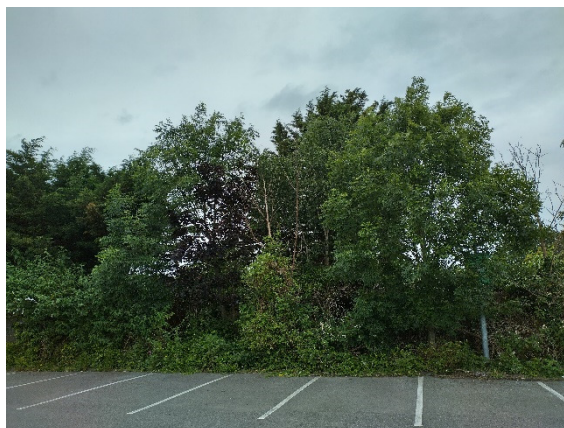
- 3.2.17 G28 and G34 from young to semi mature linear boundary groups comprised predominantly of Ash and Elm. The Ash within the groups have Ash Dieback symptoms and the Elms within the groups are dead or dying, likely due to Dutch Elm Disease. The tree groups have very limited future prospects and their removal is recommended regardless of development at the site. While G28 and G34 provide screening between the site and the adjacent residential properties, they have very limited future prospects regardless and the screening they provide could be replaced in the longer term with new tree plantings of more suitable species along the boundaries.

Photo 26: G28 from south east

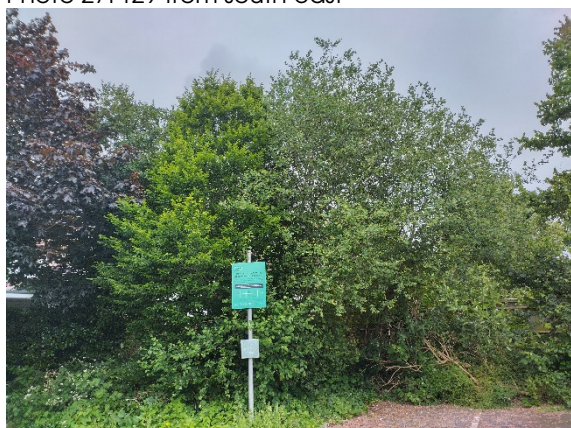
- 3.2.18 Goat Willow T33 is recommended for removal regardless of development at the site as it is situated on the edge of the existing car park at the site and its crown significantly overhangs the existing car park.

Photo 29: T31, T32 and T33 from west

T33	Goat Willow	<i>Salix caprea</i>	Semi-mature	9	3	160, 150, 110	No	2	2.5	2.5	4	4.5	Exposed roots	Multiple stemmed at base. Slight lean south west. Tight unions. Rubbing stems	Minor deadwood	Significantly overhangs car park	Good	Fair	10 to 20 yrs	Low	U	Removal recommended regardless of development
G34	Elm. Ash. Hawthorn. Elder.	<i>Ulmus sp.</i> <i>Fraxinus sp.</i> <i>Crataegus sp.</i> <i>Sambucus sp.</i>	Semi-mature	9	100	100	No	0.5	See plan				Exposed roots	Old pruning wounds. Bark damage. Tight unions. Partially included bark. Stubs. Ash Dieback symptoms. Dutch Elm Disease symptoms	Moderate dieback. Minor deadwood. Ash Dieback symptoms. Dutch Elm Disease symptoms	Linear group of young to semi mature trees. Situated between car park and boundary fence. Ash and Elm with occasional shrubby Elder and Hawthorn. Elms are dead or have significant dieback, likely due to Dutch Elm Disease. Ash have Ash Dieback symptoms.	Poor	Fair	<10 yrs	Moderate	U	Removal recommended regardless of development

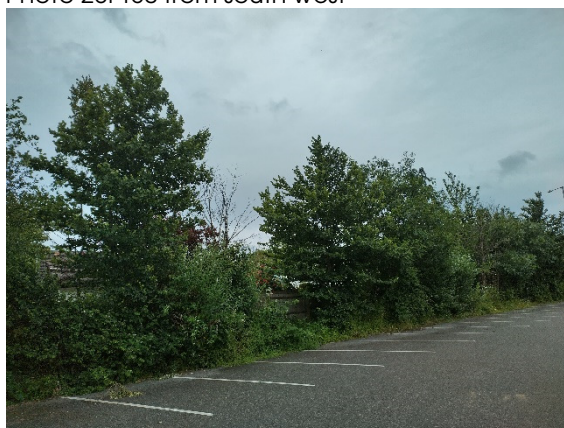
Photo 30: G34 from north west
