Phase 2 Ground Investigation

Client: Lidl Great Britain
Ltd

Ickenham Road, Ruislip

Report No: 1246.02.01

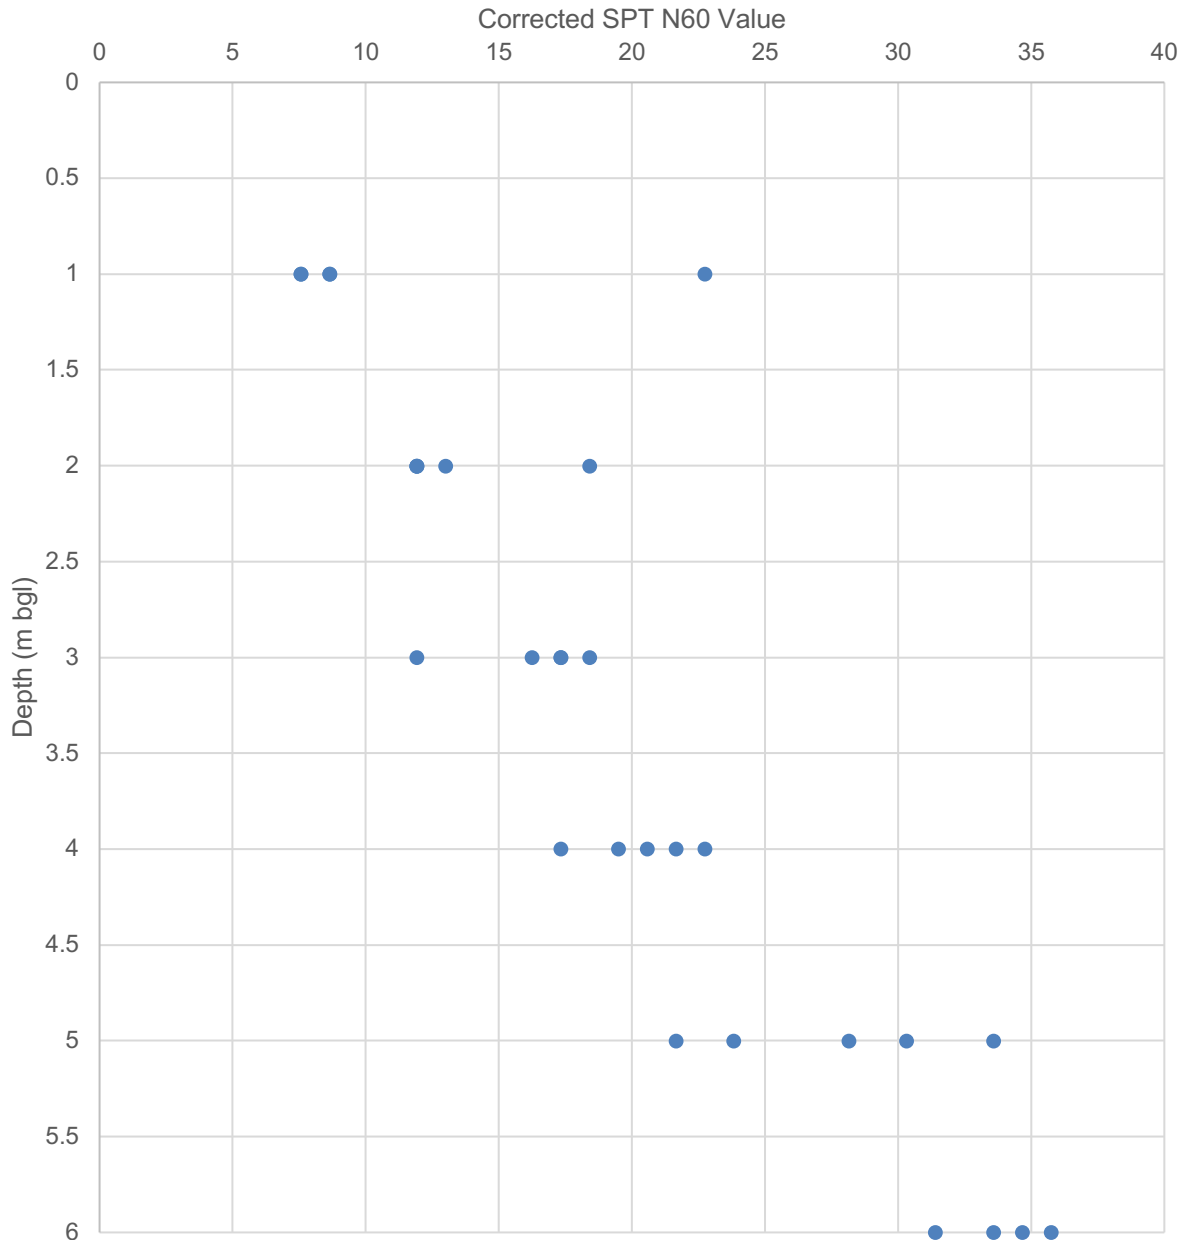
Graph 1: Plot of Corrected SPT N-Values Versus Depth

In-situ SPTs were undertaken to assist with the interpretation of strata encountered. The results of corrected N-values versus depth are plotted in the graph below:

Uncorrected SPT N-values at 1.0m bgl within the nine exploratory boreholes ranged between 7 and 21, whilst at 2.0m depth these ranged between 9 and 17. Groundwater seepages were noted in WS9 at 0.50m bgl within the Made Ground deposits, and in WS4 at 7.00m bgl and WS5 at 5.00m bgl within the natural deposits.

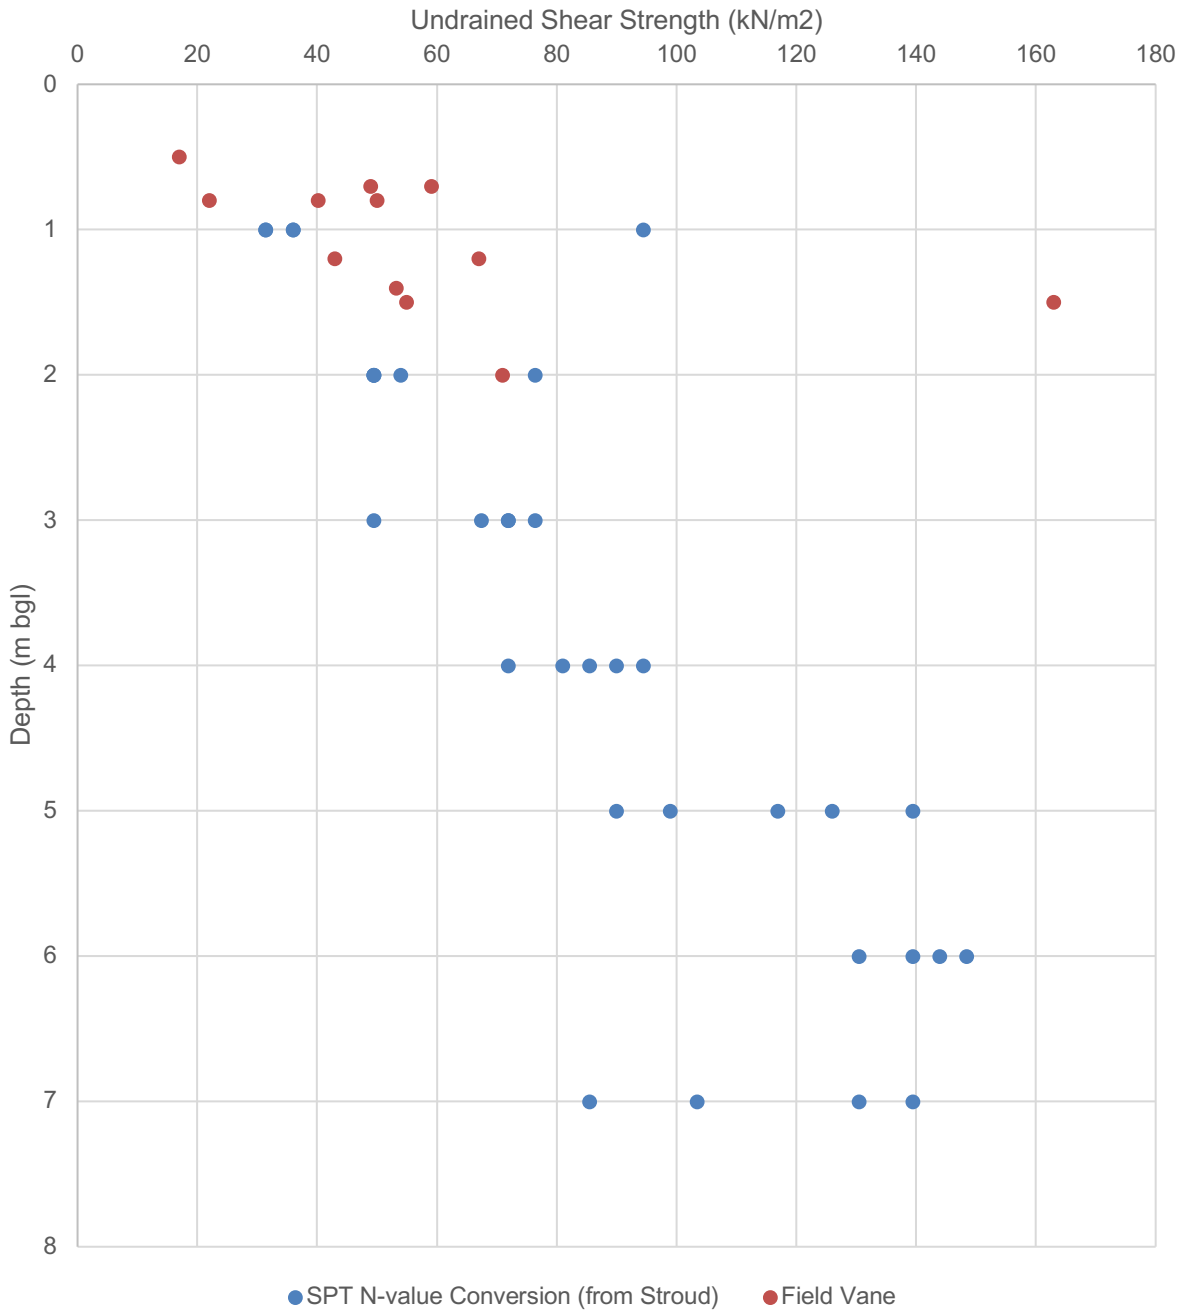
Graph 2: Plot of Mass Shear Strength Versus Depth.

Where f_1 is based on the plasticity index.

A Plasticity Index of 37% has been assumed (based on geotechnical laboratory testing) which equates to an f_1 factor of 4.5.

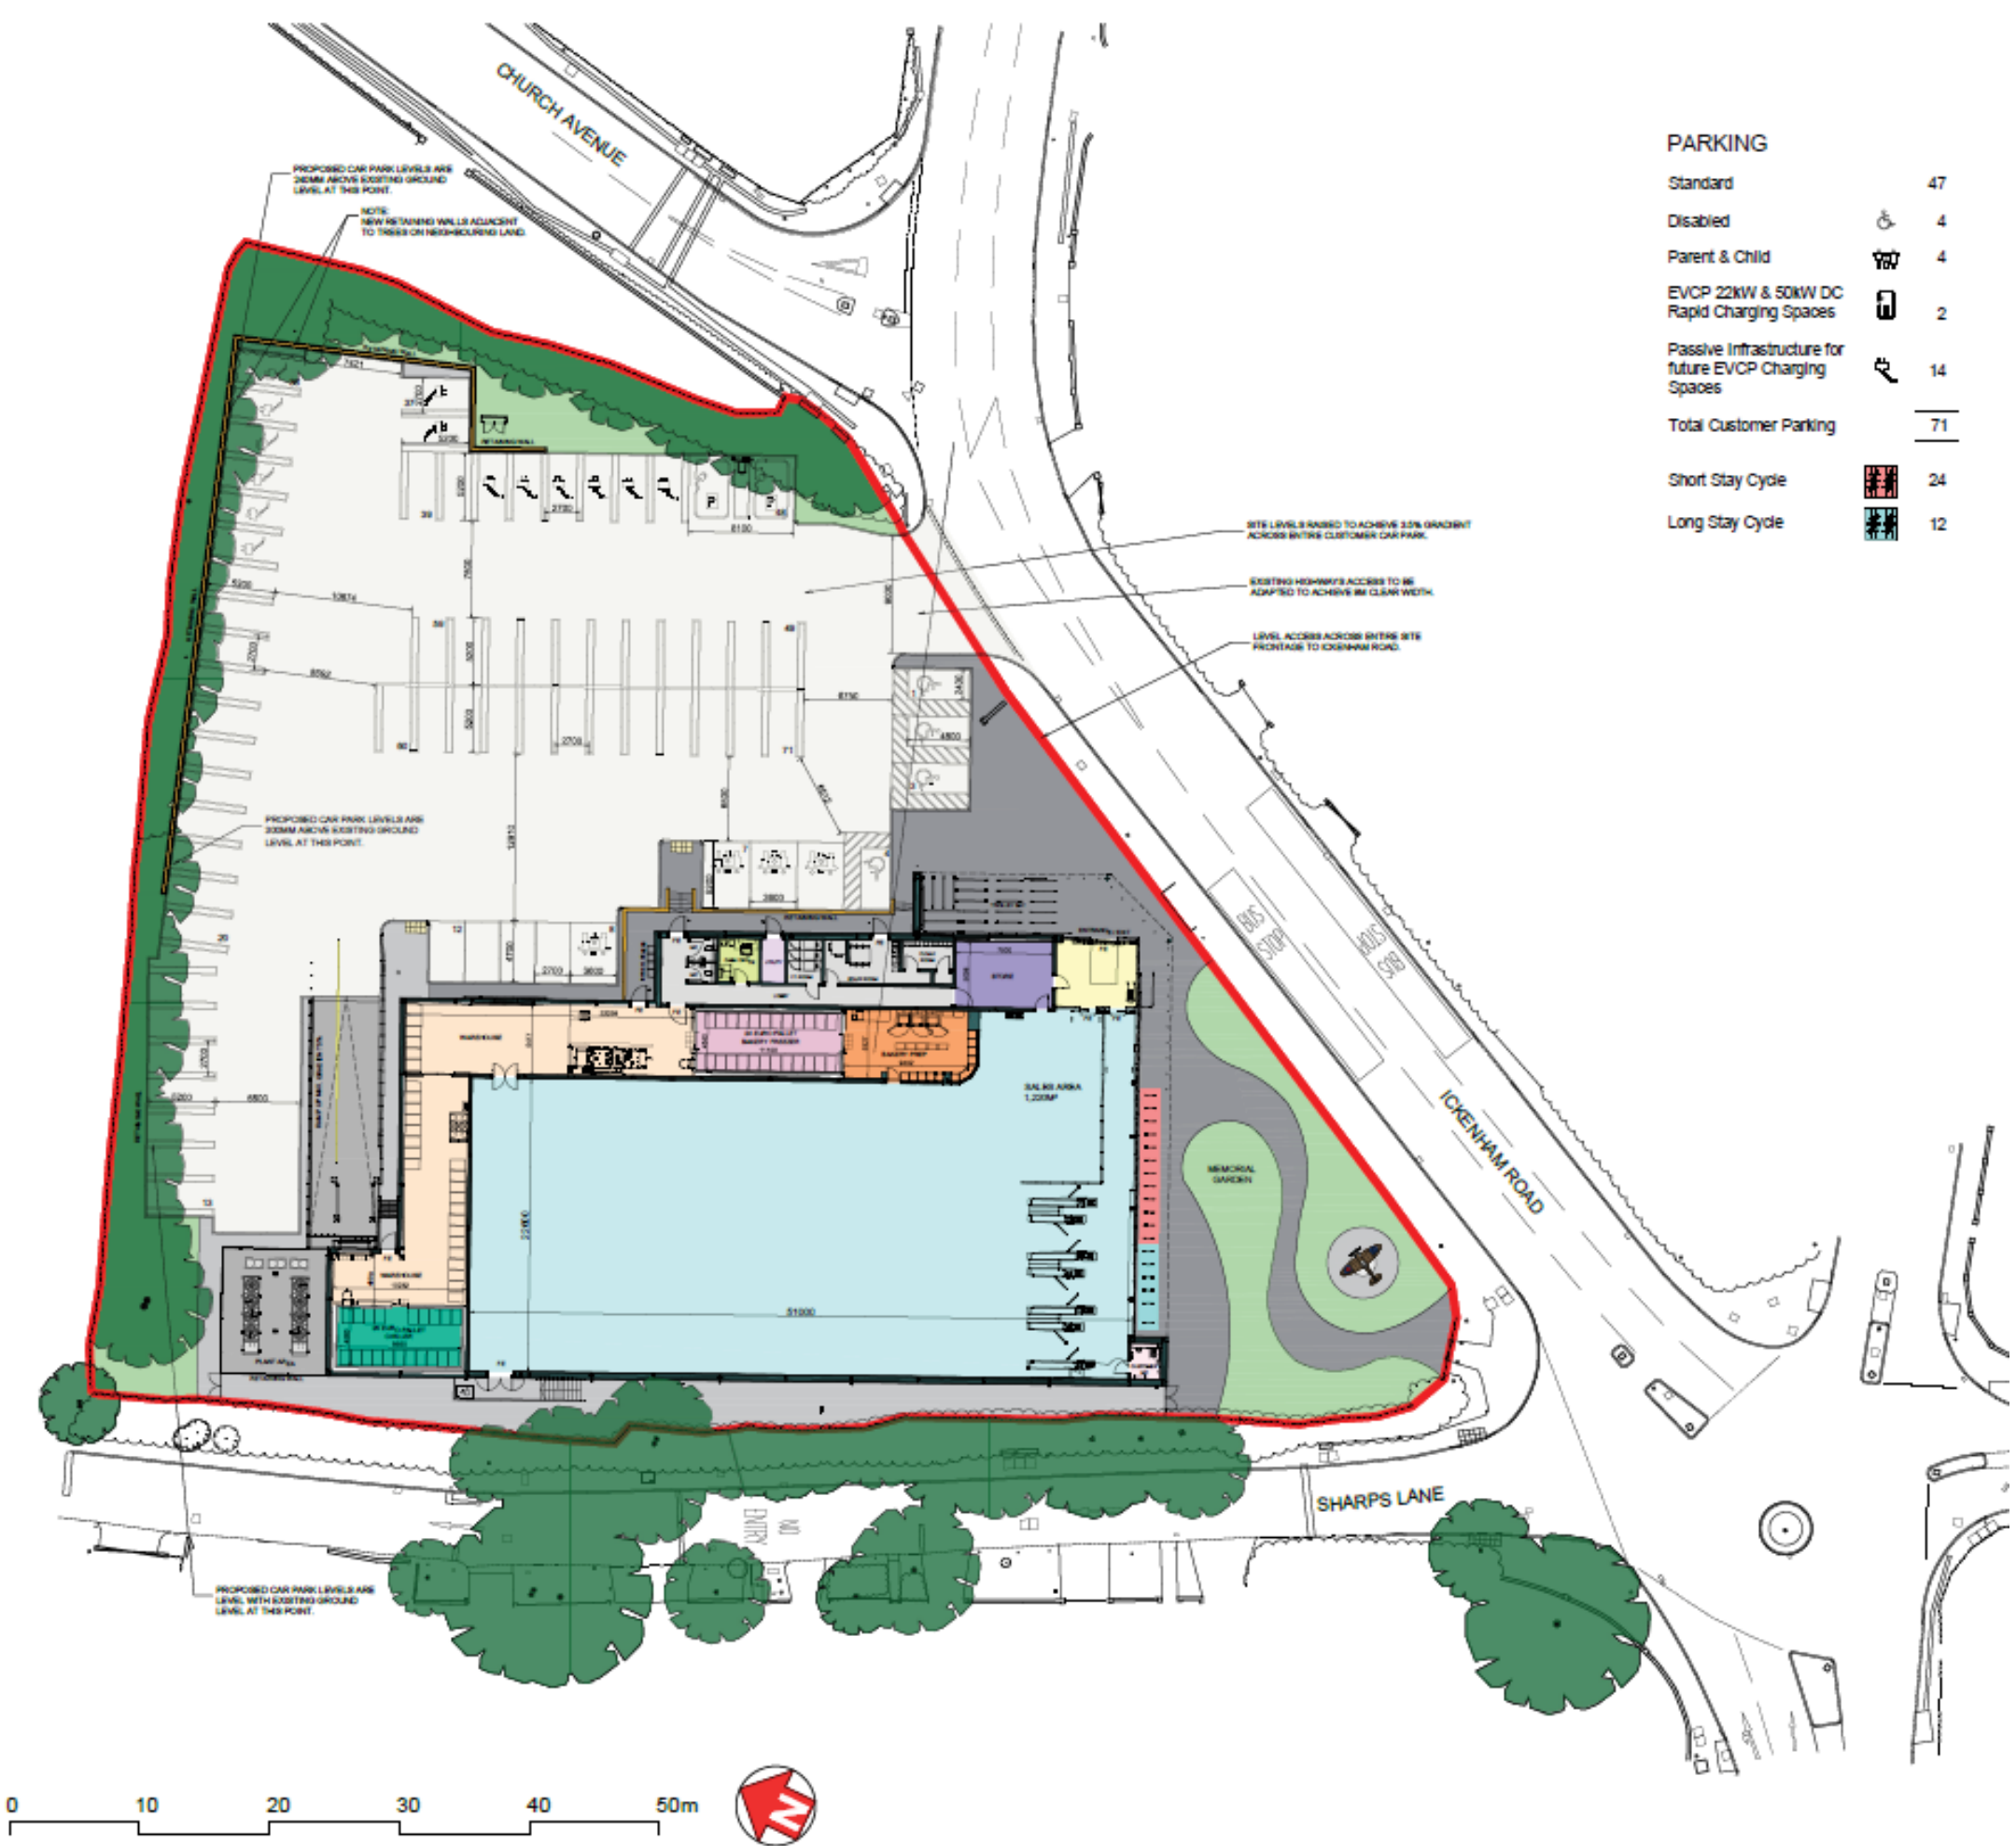
PARKING

Standard		47
Disabled		4
Parent & Child		4
EVCP 22KW & 50KW DC Rapid Charging Spaces		2
Passive Infrastructure for future EVCP Charging Spaces		14
Total Customer Parking		71
Short Stay Cycle		24
Long Stay Cycle		12

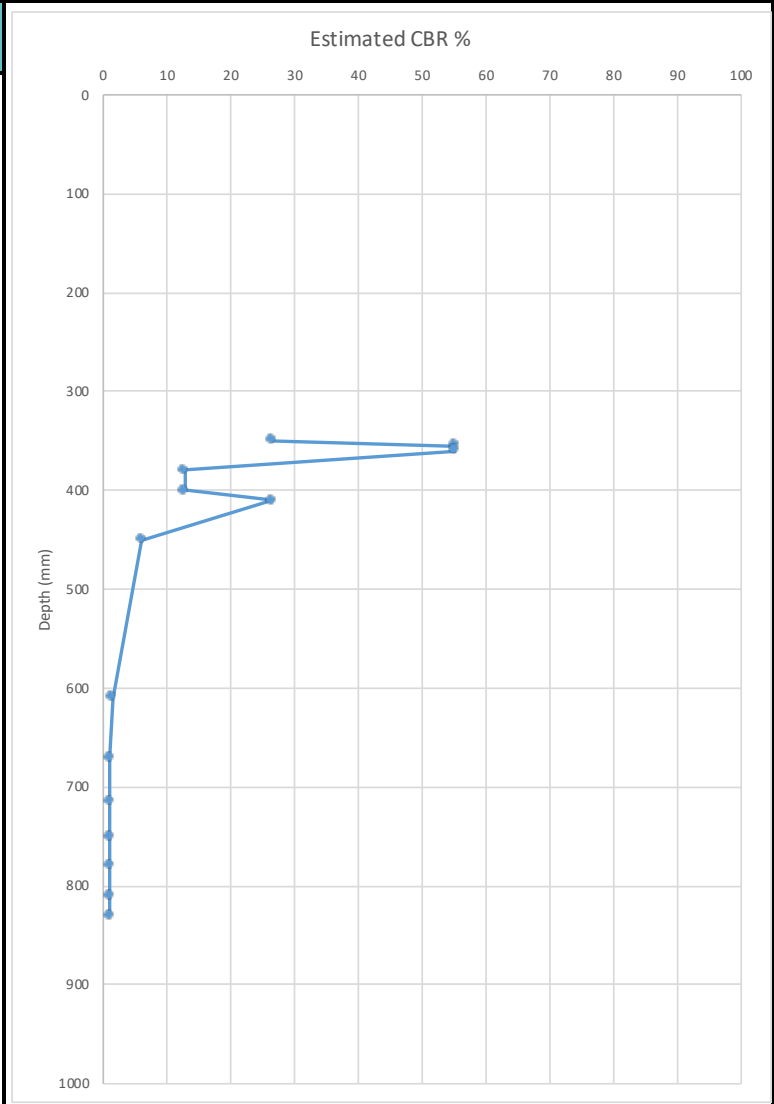
Client:	Lidl Great Britain Ltd	Site Location:	Ickenham Road, Ruislip	Test No:	CBR1	Location:	508843, 187223
Project No:	1246.02	Date:	26.03.24	Start Depth:	Surface	Test Strata:	Made Ground/ Soft clay
$\text{Log}_{10}(\text{CBR}) = 2.480 - 1.057 \times \text{Log}_{10}(\text{mm}/\text{blow})$						Weather:	Dry Sunny

No of Blows	Depth Reading mm	Penetration/ Blow mm	CBR %
0	340	0	
1	350	10.0	26.5
2	355	5.0	55.1
3	360	5.0	55.1
4	380	20.0	12.7
5	400	20.0	12.7
6	410	10.0	26.5
7	450	40.0	6.1
8	610	160.0	1.4
9	670	60.0	1.0
10	715	45.0	1.0
11	750	35.0	1.0
12	780	30.0	1.0
13	810	30.0	1.0
14	830	20.0	1.0

CBR values estimated from the DCP tests indicated that, near surface the CBR values were variable and a value of 2% should be adopted at a depth of 0.4m below existing car park level. Poorly compacted made ground backfill resulting from the demolition works should be excavated, processed as necessary to produce a 6F2 material and replaced in compacted layers in accordance with an engineering specification.

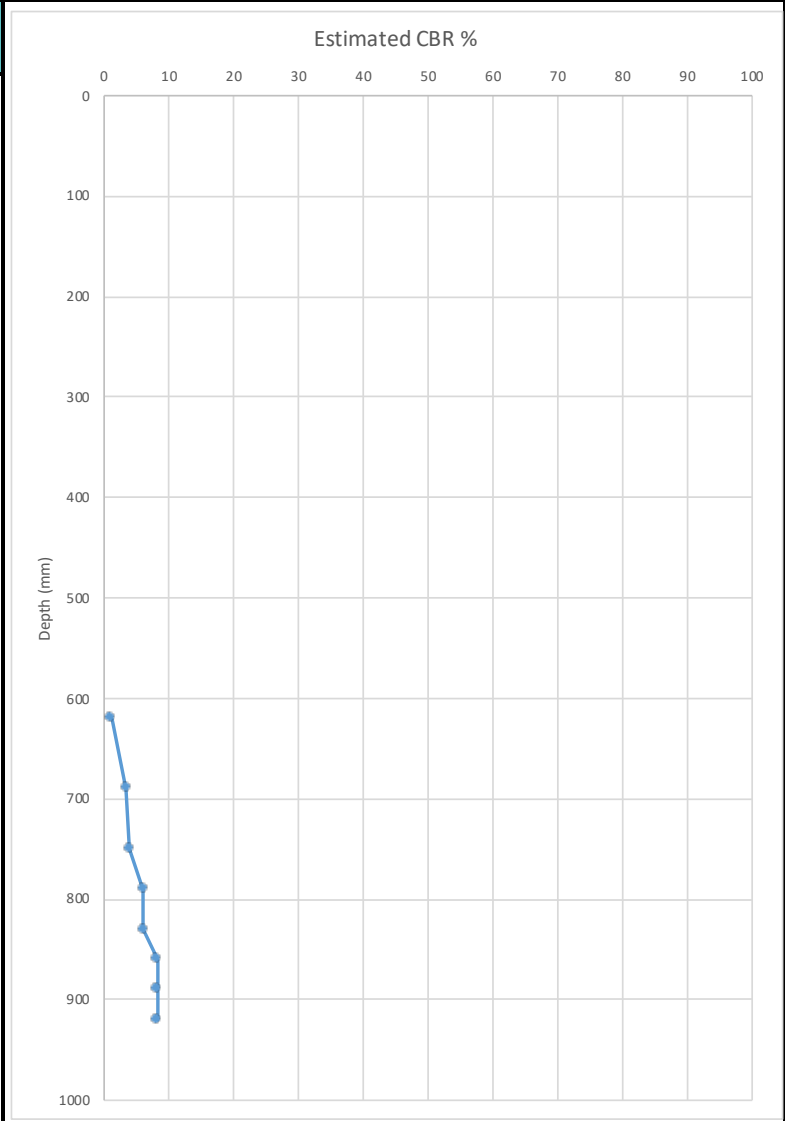
Client:	Lidl Great Britain Ltd	Site Location:	Ickenham Road, Ruislip	Test No:	CBR2	Location:	508825, 187201
Project No:	1246.02	Date:	26.03.24	Start Depth:	0.20m	Test Strata:	Made Ground/ Soft to firm clay
$Log_{10}(CBR) = 2.480 - 1.057 \times Log_{10}(mm/blow)$						Weather:	Dry Sunny

No of Blows	Depth Reading mm	Penetration/ Blow mm	CBR %
0	435	0	
1	620	185.0	1.2
2	690	70.0	3.4
3	750	60.0	4.0
4	790	40.0	6.1
5	830	40.0	6.1
6	860	30.0	8.3
7	890	30.0	8.3
8	920	30.0	8.3

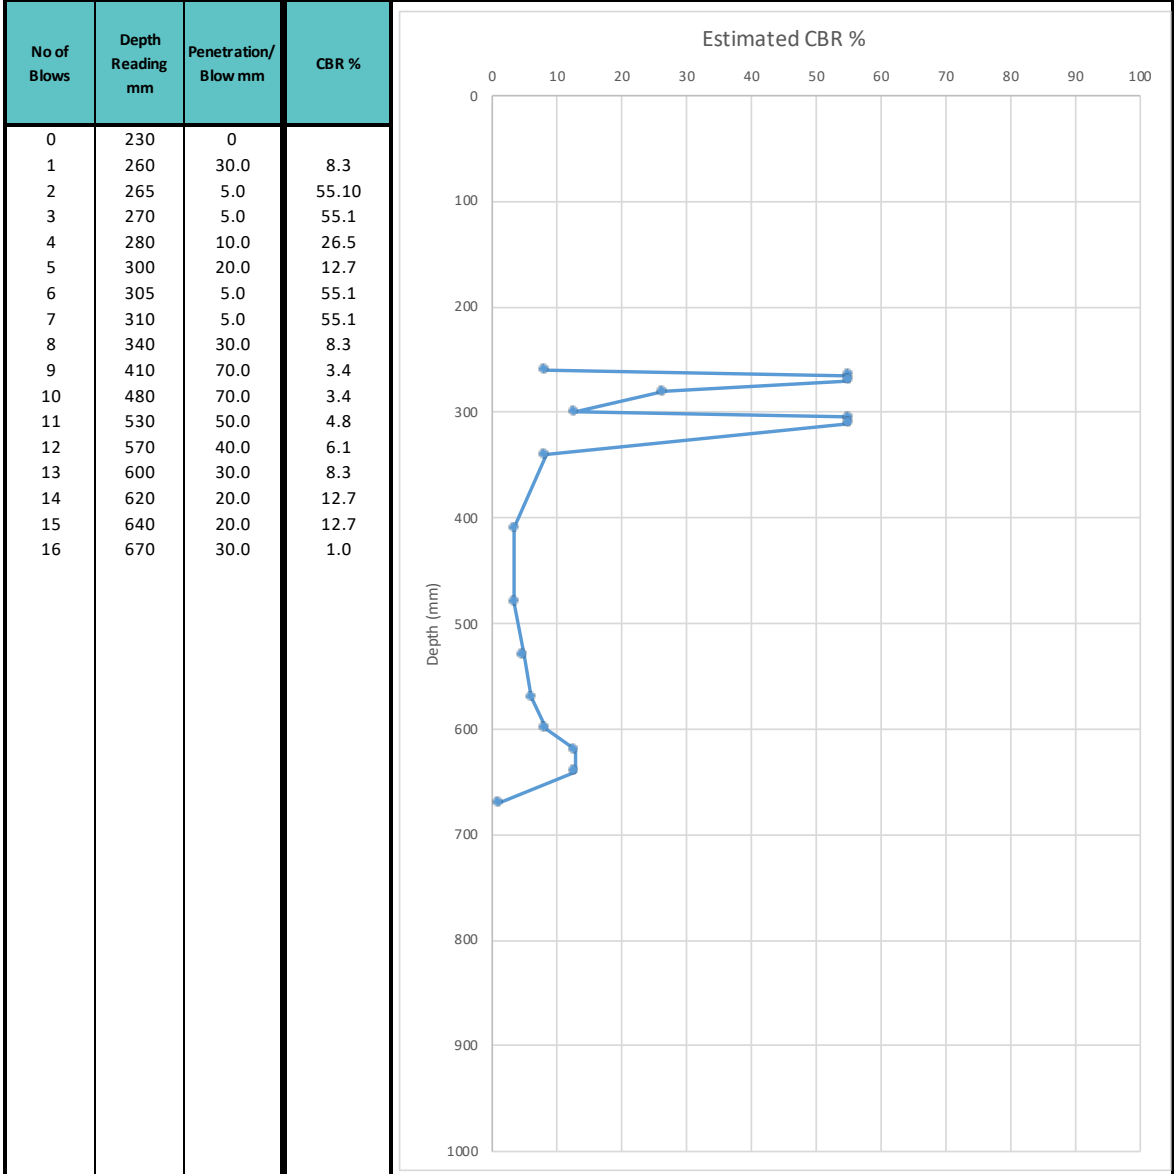
Client:	Lidl Great Britain Ltd	Site Location:	Ickenham Road, Ruislip	Test No:	CBR4	Location:	508840, 187196
Project No:	1246.02	Date:	26.03.24	Start Depth:	Surface	Test Strata:	Subbase/ Soft to firm clay
$Log_{10}(CBR) = 2.480 - 1.057 \times Log_{10}(mm/blow)$						Weather:	Dry Sunny

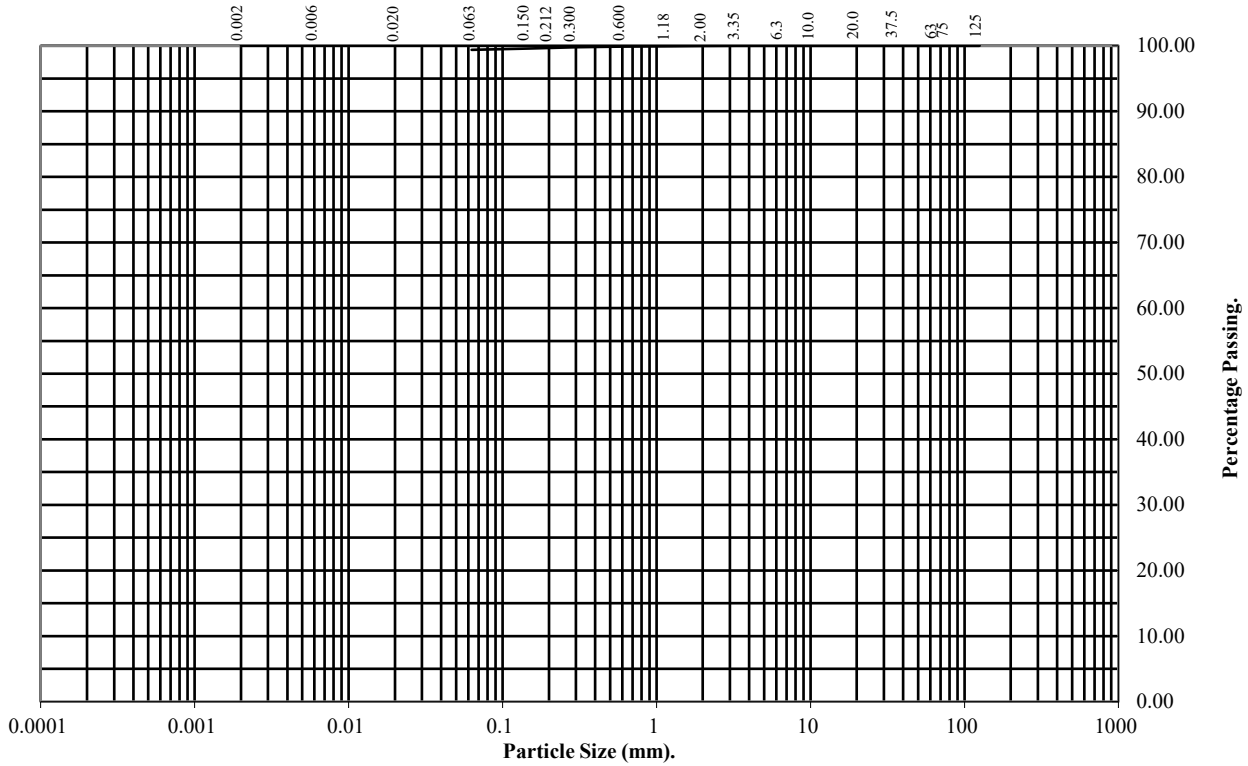
BS Test Sieve (mm)	Percentage Passing
125	100
75	100
63	100
37.5	100
20	100
10	100
6.3	100
3.35	100
2	100
1.18	100
0.6	100
0.3	100
0.212	100
0.15	100
0.063	99

Soil Fraction	Total Percentage
Cobbles	0
Gravel	0
Sand	1
Silt/Clay	99
