ARBORICULTURAL REPORT

to BS 5837:2012 at:

***Premier Inn London Ruislip,
Ickenham Road,
Ruislip
HA4 7DR***

Reference: *AWA6395*

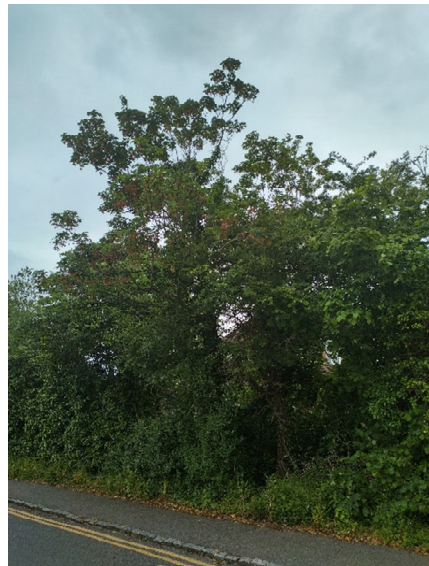
Photo 18: T20 from south west

4.2.6 T19 and T20 are larger more prominent early mature trees and their removal will have some negative impact, however Ash T19 likely has limited long term value regardless of development at the site due to Ash Dieback. The screening the trees provide between the site and the adjacent residential properties could be replaced could be replaced in the longer term with new tree plantings of more suitable species along the boundary.

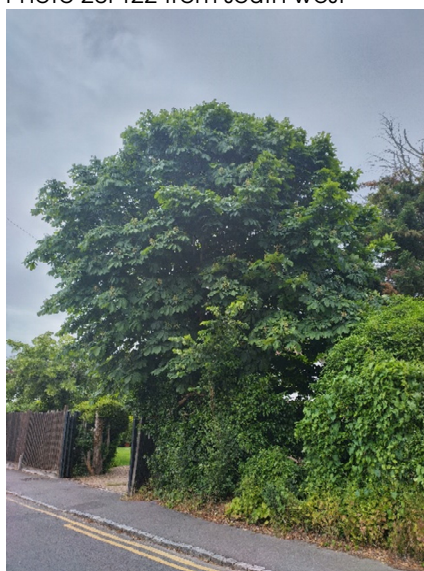
Photo 22: T24 from south west

- 3.2.19 T24, G27, T29 and T30 are situated in gardens of adjacent properties to the north of the site and so were only given cursory inspections with measurements estimated and condition values indicative only.

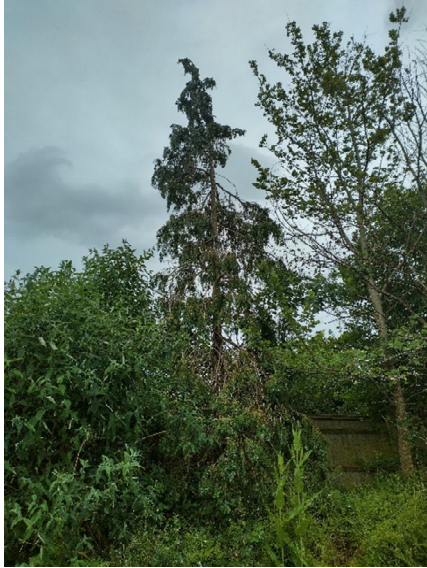
Photo 31: T35 from west

Tree Species		Measurements						Crown (m)				Tree Condition						Value		Management		
Tree ID	Common Name	Latin Name	Maturity	Height (m)	Stems	Stem Diameter (mm)	Estimated	Crown height	N	E	S	W	Roots	Stem	Crown	Comments	Physiological	Structural	Life Expectancy	Amenity	Category	Works
T35	Cypress	<i>Cupressus sp.</i>	Semi-mature	8	1	120	No	0.5	1.5	1.5	1.5	1.5	No visual defects	Single stemmed. Slight lean east. Ivy covered	Minor dieback. Major dieback. Minor deadwood. Moderate dieback. Ivy covered	Significant dieback	Fair	Fair	10 to 20 yrs	Low	C	No works required
